11 October 2010

Asbestos Materials Survey – Blackmores First Lady (NMC # 00033167)

Parsons Brinckerhoff (PB) was engaged by the Australian National Maritime Museum (ANMM) to undertake an asbestos materials survey of Blackmores First Lady located at the ANMM. The site investigation was conducted by PB on 6 October 2010.

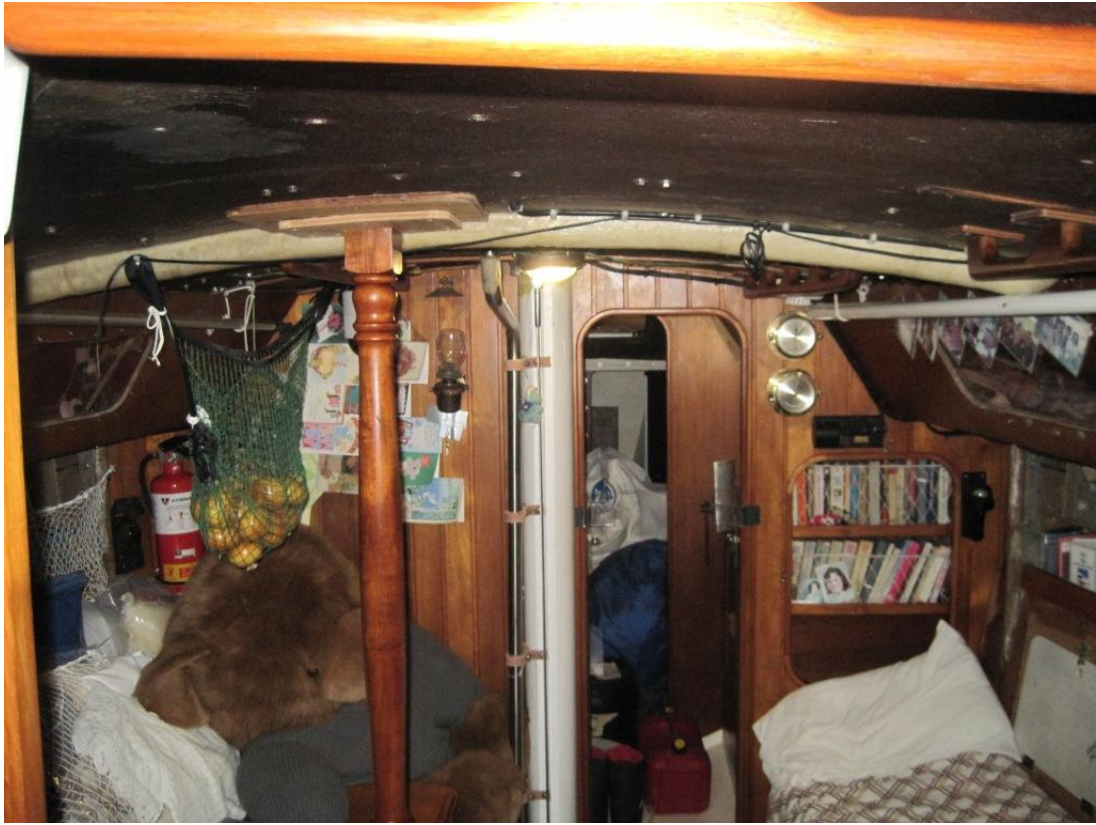
Figure 1: Interior of Blackmores First Lady
